Series e-90 & e-1535 Replacement Seal Instructions

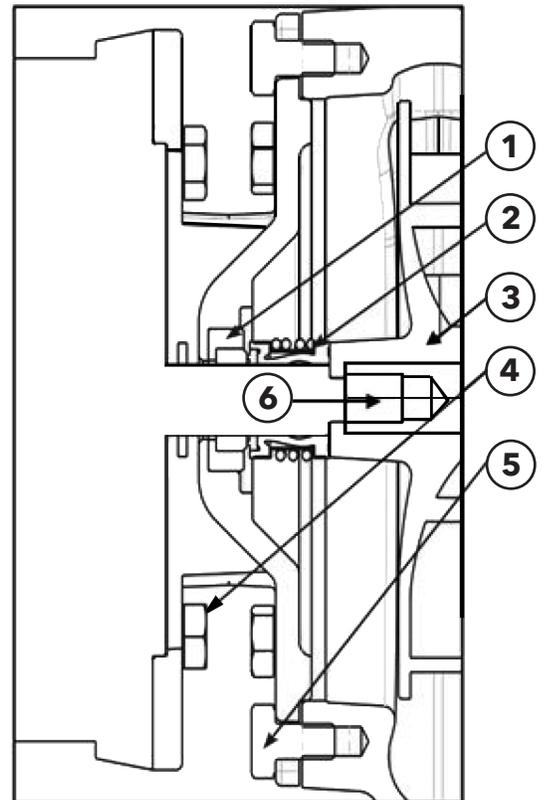
1. Seal Seat
2. Seal Head
3. Impeller
4. Motor Capscrew
5. Volute Capscrew
6. Jam Nut

Using a socket wrench on the jam nut and large screwdriver or an end wrench and a strap wrench on the impeller OD. Turn the jam nut and impeller counterclockwise to unscrew it from the motor shaft. The jam nut is held in place with Loctite and torque. Do not insert anything between the impeller vanes or motor fan blades as damage may occur.

Grab the OD of the seal head assembly and remove. Remove the four capscrews that hold the bracket to the motor and remove the bracket. Push the cup mounted seal seat out of the bracket with a small screwdriver.
